RVI Inspection Report

HD 4 'Hendrik Petronella'

SWD 6SW280 Main Engine

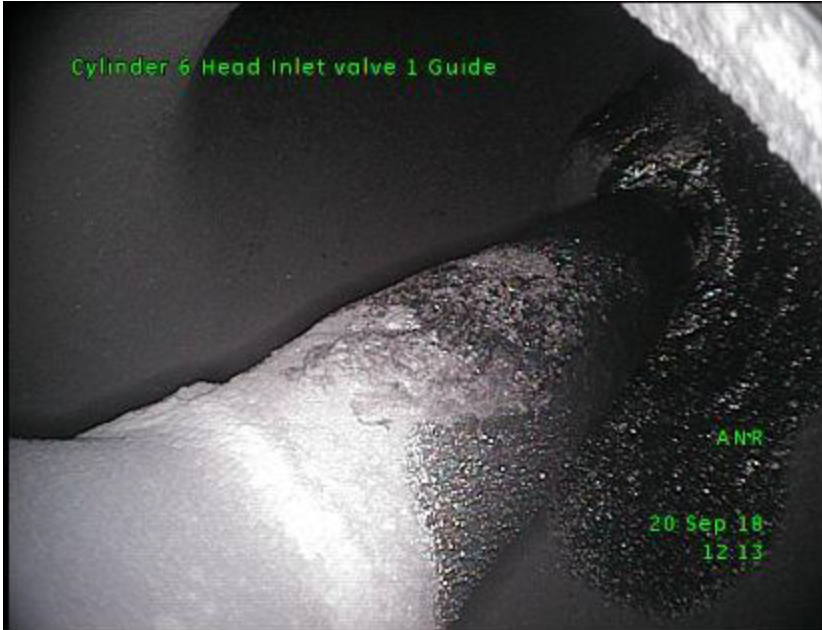
Cylinder No.	Cylinder 6
Group	Head
Part	Inlet valve 1
Position	Guide
Comments	Some fouling is visible.

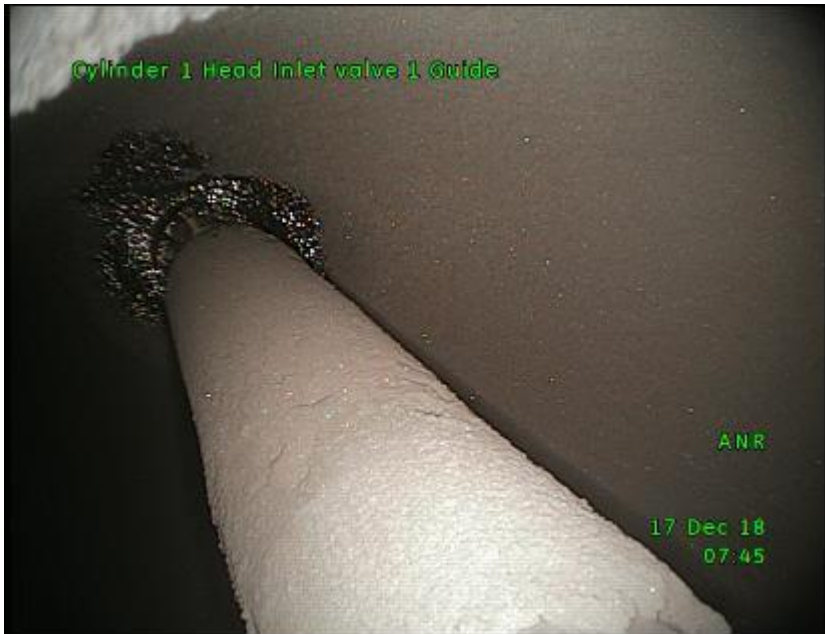
Cylinder_1_Head_Inlet_valve_1_Left002.BMP

Cylinder No.	Cylinder 1
Group	Head
Part	Inlet valve 1
Position	Guide
Comments	Some fouling is visible. Less oil leakage along the valve guide compared to previous inspection (20-09-2018)

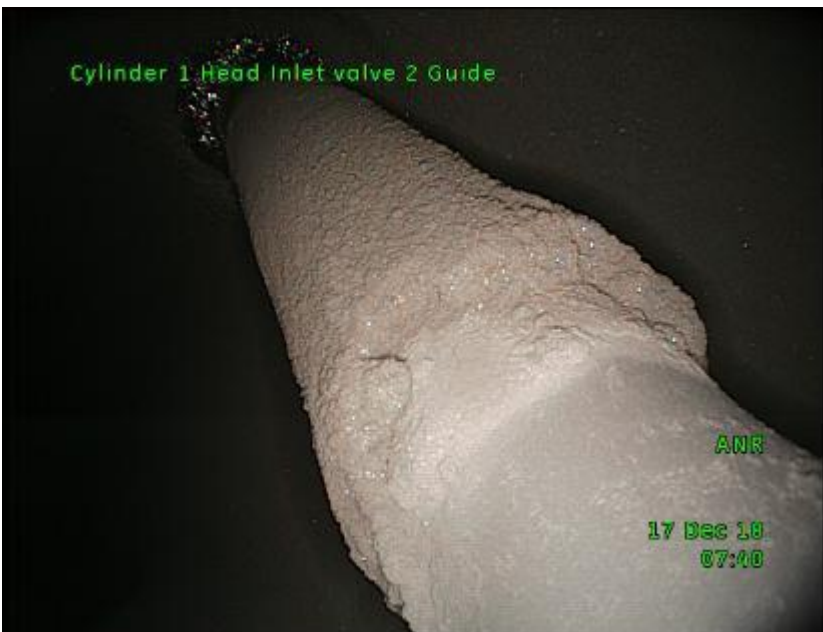
Cylinder No.	Cylinder 1
Group	Head
Part	Inlet valve 2
Position	Guide
Comments	Some fouling is visible. Less oil leakage along the valve guide. Less fouling compared to previous inspection (20-09-2018)
